CLOSING THE GAP

MAOP VALIDATION

Christopher De Leon
ROMAT PGS: Closing the Gap - © ROSEN Group - 2016

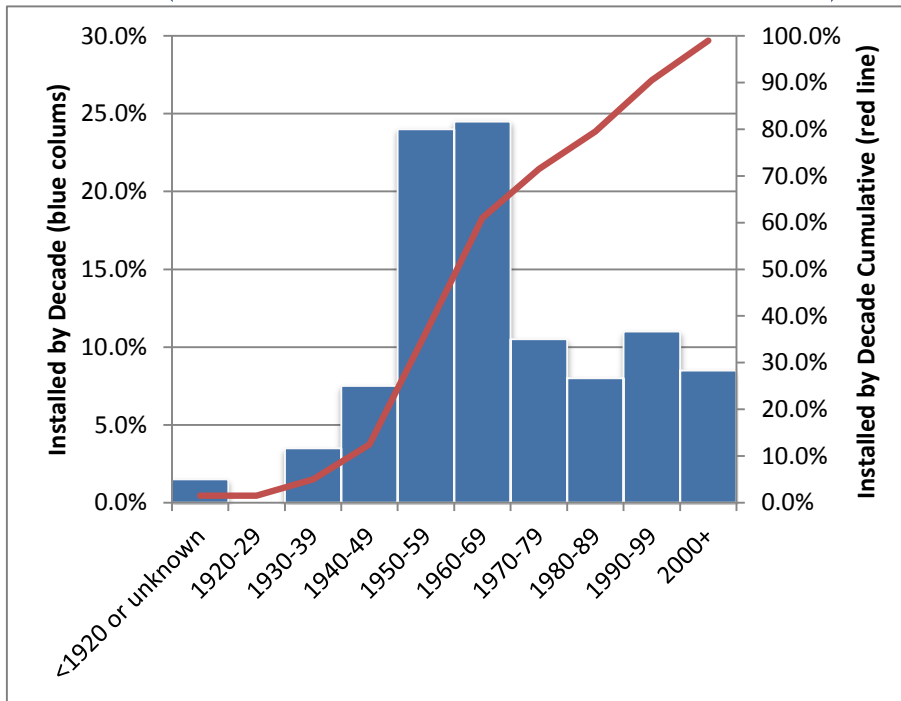
Percentage of gas transmission pipeline mileage installed in the USA [1]

- 305,000 miles (490,850 km) of natural gas transmission pipelines in the USA
- Approx. 50% of all pipelines installed between 1950 and 1970
- Approx. 66% of all pipelines installed prior to 1970 (“pre-regulation pipelines”)

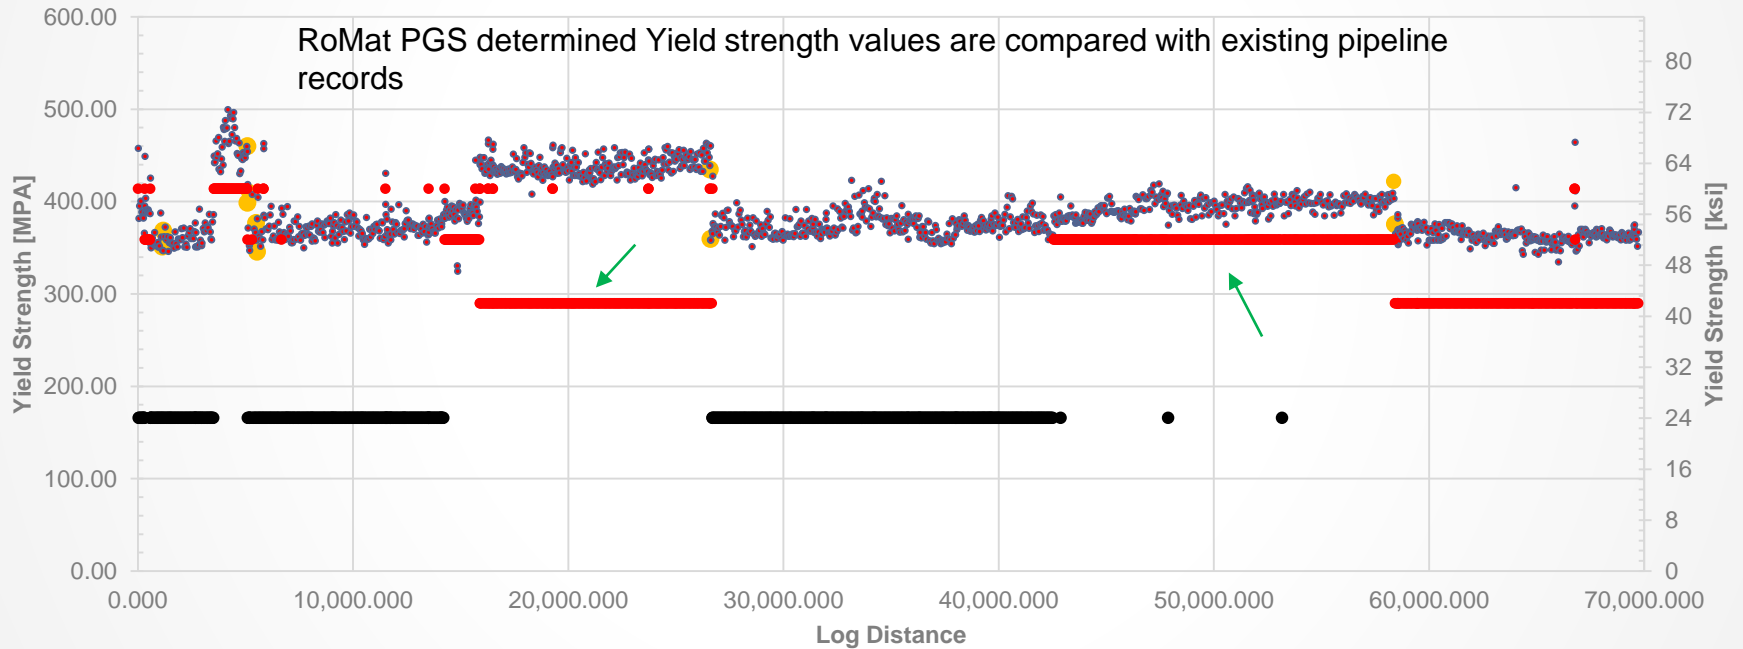
ROMAT PGS – THE DATA EVALUATION PROCESS

Determination per pipe joint

- Yield strength per joint (ILI)
- yield strength per joint (hardness testing)
- Sections with pipeline records
- Sections with unknown grade

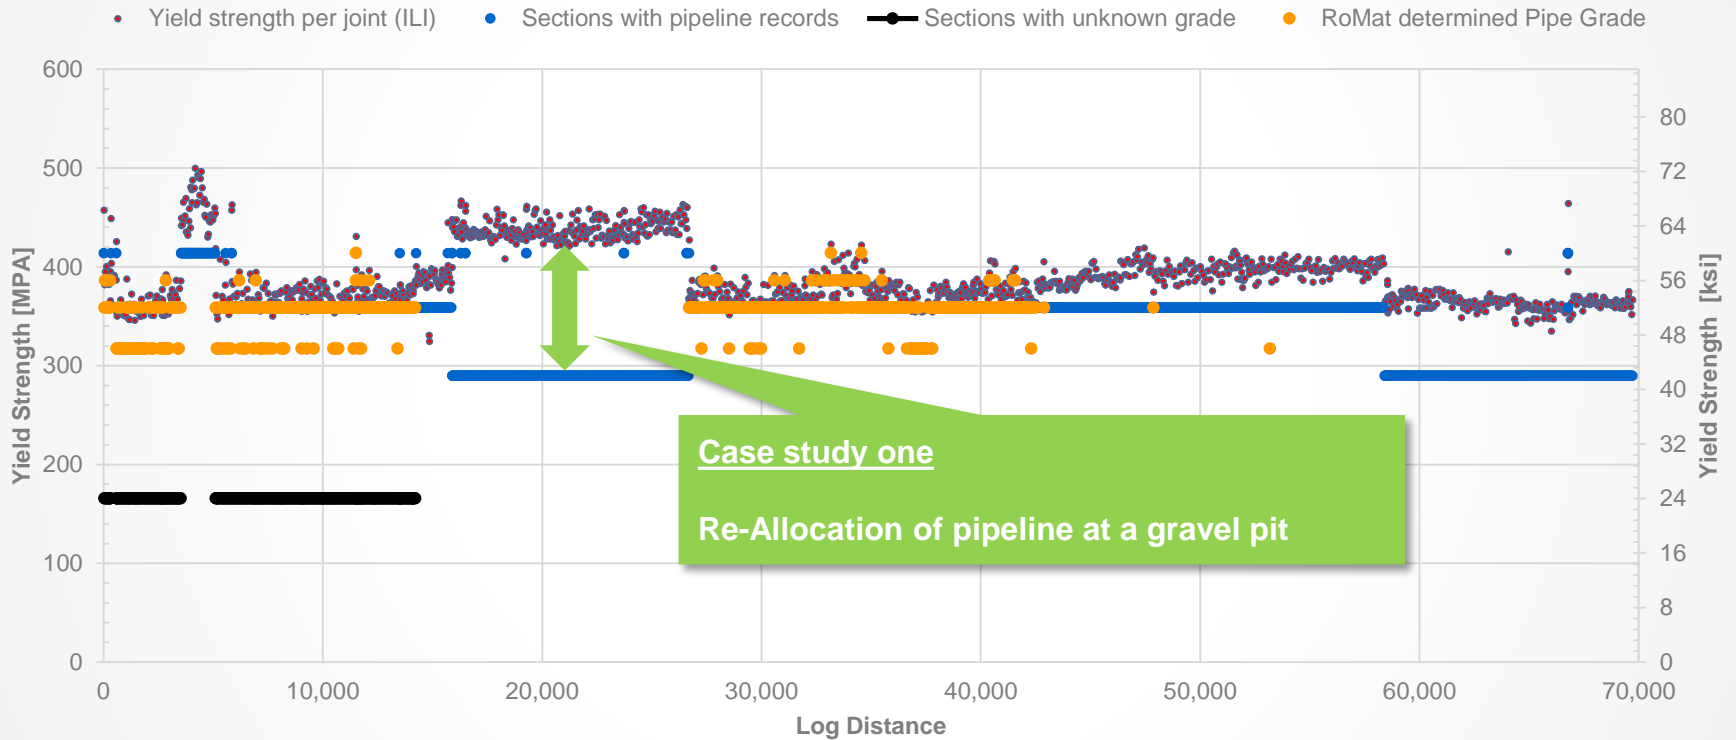
16" Pipeline – Pipe Grade Determination

CASE STUDY ONE

Re-Allocation of pipe line at a gravel pit

Ordered pipe:	X 42; API 5 L
Delivered pipe:	X42/ X52; API 5L
	Requirement for yield strength
	X 42 Min./Max. Yield 42 ksi/72ksi
	X 52 Min./Max. Yield 52 ksi/77ksi
Investigation on mill certs:	yield strength between 58 ksi and 62 ksi
Tool measurements:	yield strength between 60 ksi and 63 ksi
Inspection System Result Verification insitu:	verification joint = 63.02 ksi

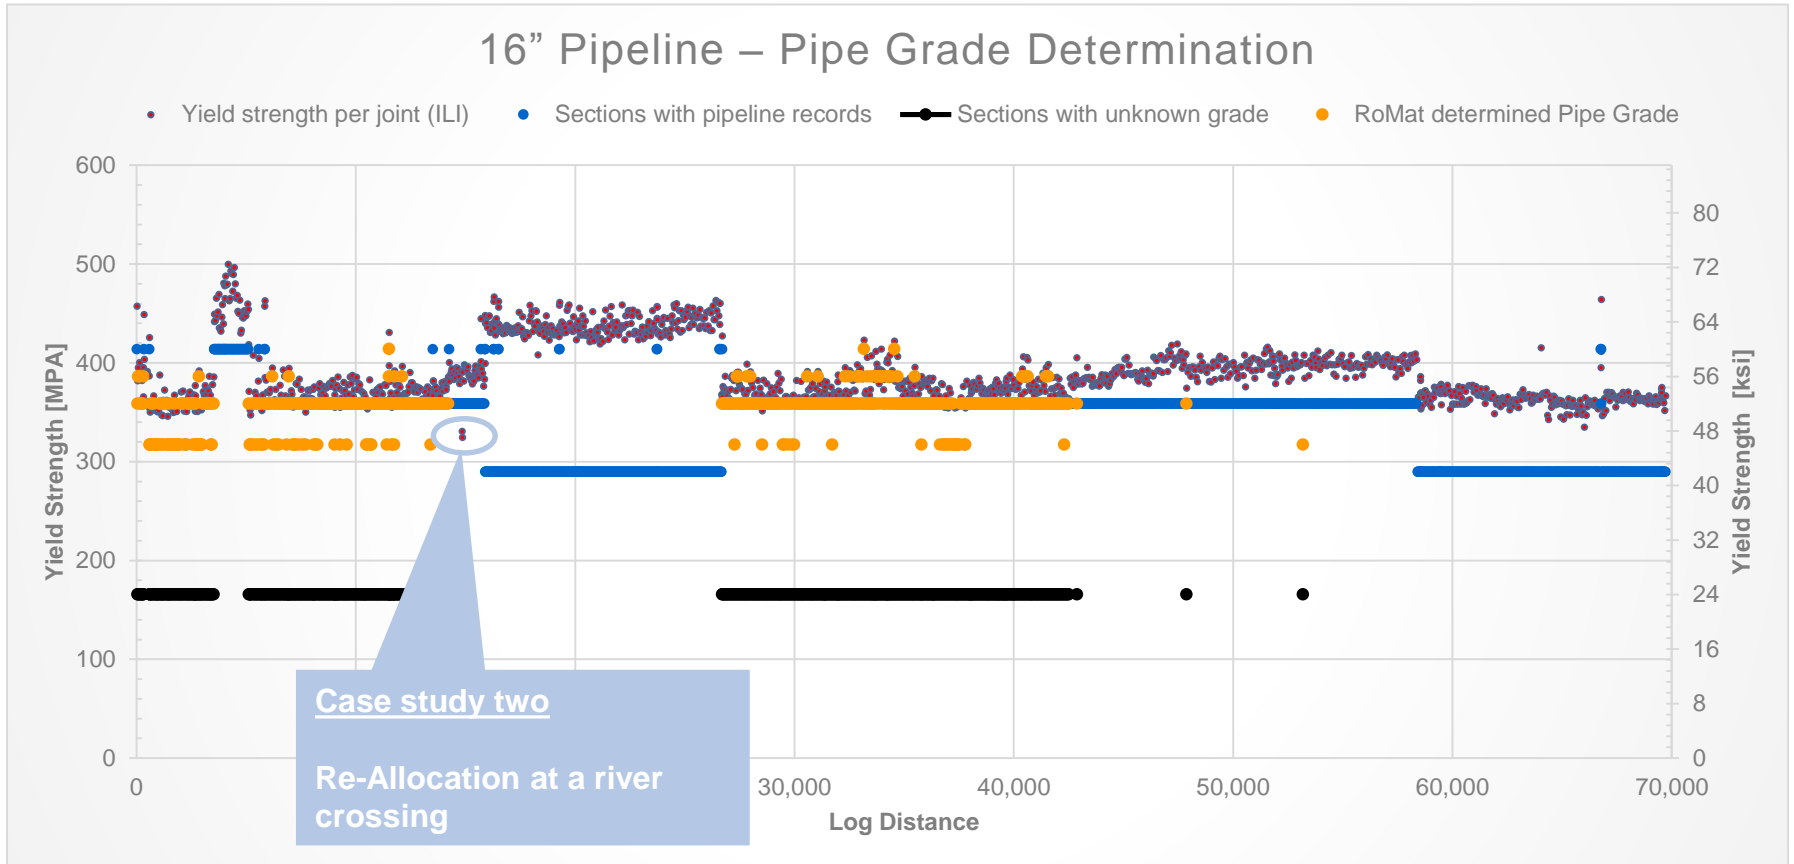
CASE STUDY TWO

Re-Allocation of pipe line at a river crossing

Ordered pipe:	X 52; API 5 L
Delivered pipe:	X 52; API 5L
	Requirement for yield strength
	X 52 = Min./Max. Yield 52 ksi/77ksi
Tool measurements:	Section: 55 ksi until 58 ksi
	Outlier 1 yield strength 47.94 ksi
	Outlier 2 yield strength 47.09 ksi

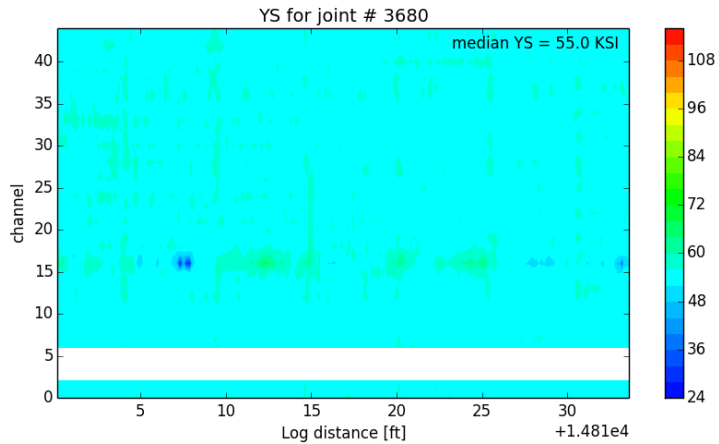
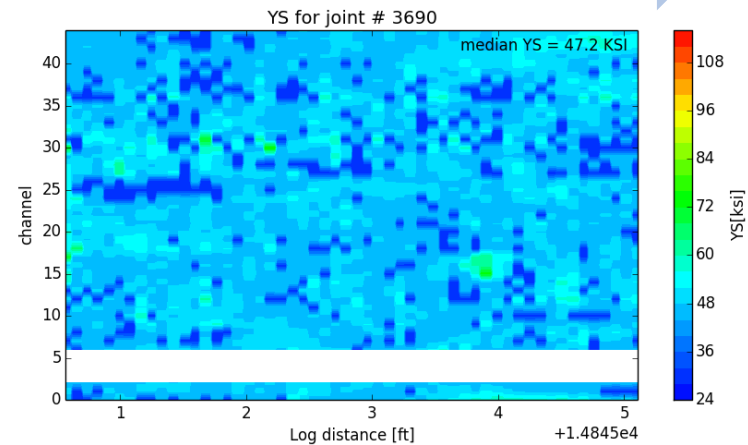
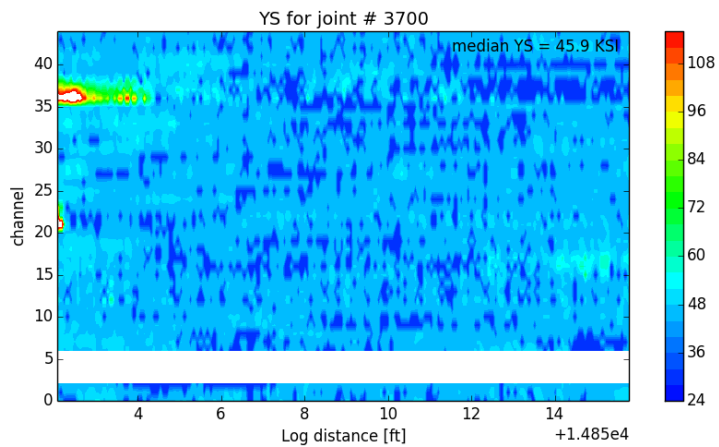
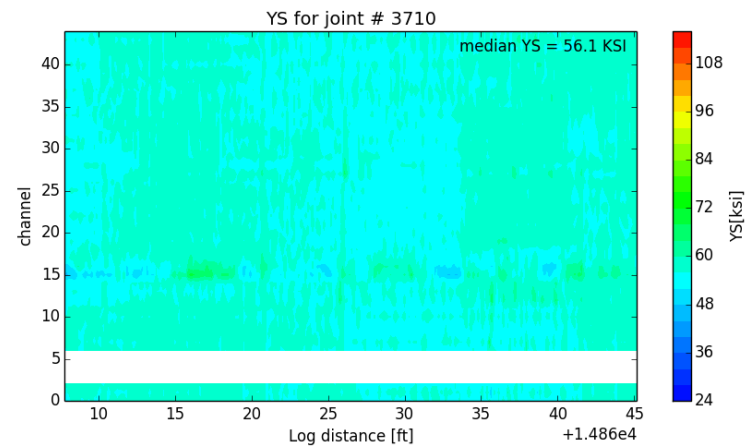
CASE STUDY TWO – PIPE GRADE PLOTS

Ordered pipe: X 52; API 5 L
Delivered pipe: X 52; API 5L
Requirement for yield strength
X 52 = Min./Max. Yield 52 ksi/77ksi

Tool measurements: Section: 55 ksi until 58 ksi
Outlier 1 yield strength 47.94 ksi
Outlier 2 yield strength 47.09 ksi

Discrepancy was found between MAOP record and As-Built at the river crossing. As-Built indicated pups were installed but no material records were found. Joints established as X-46 per ILI.

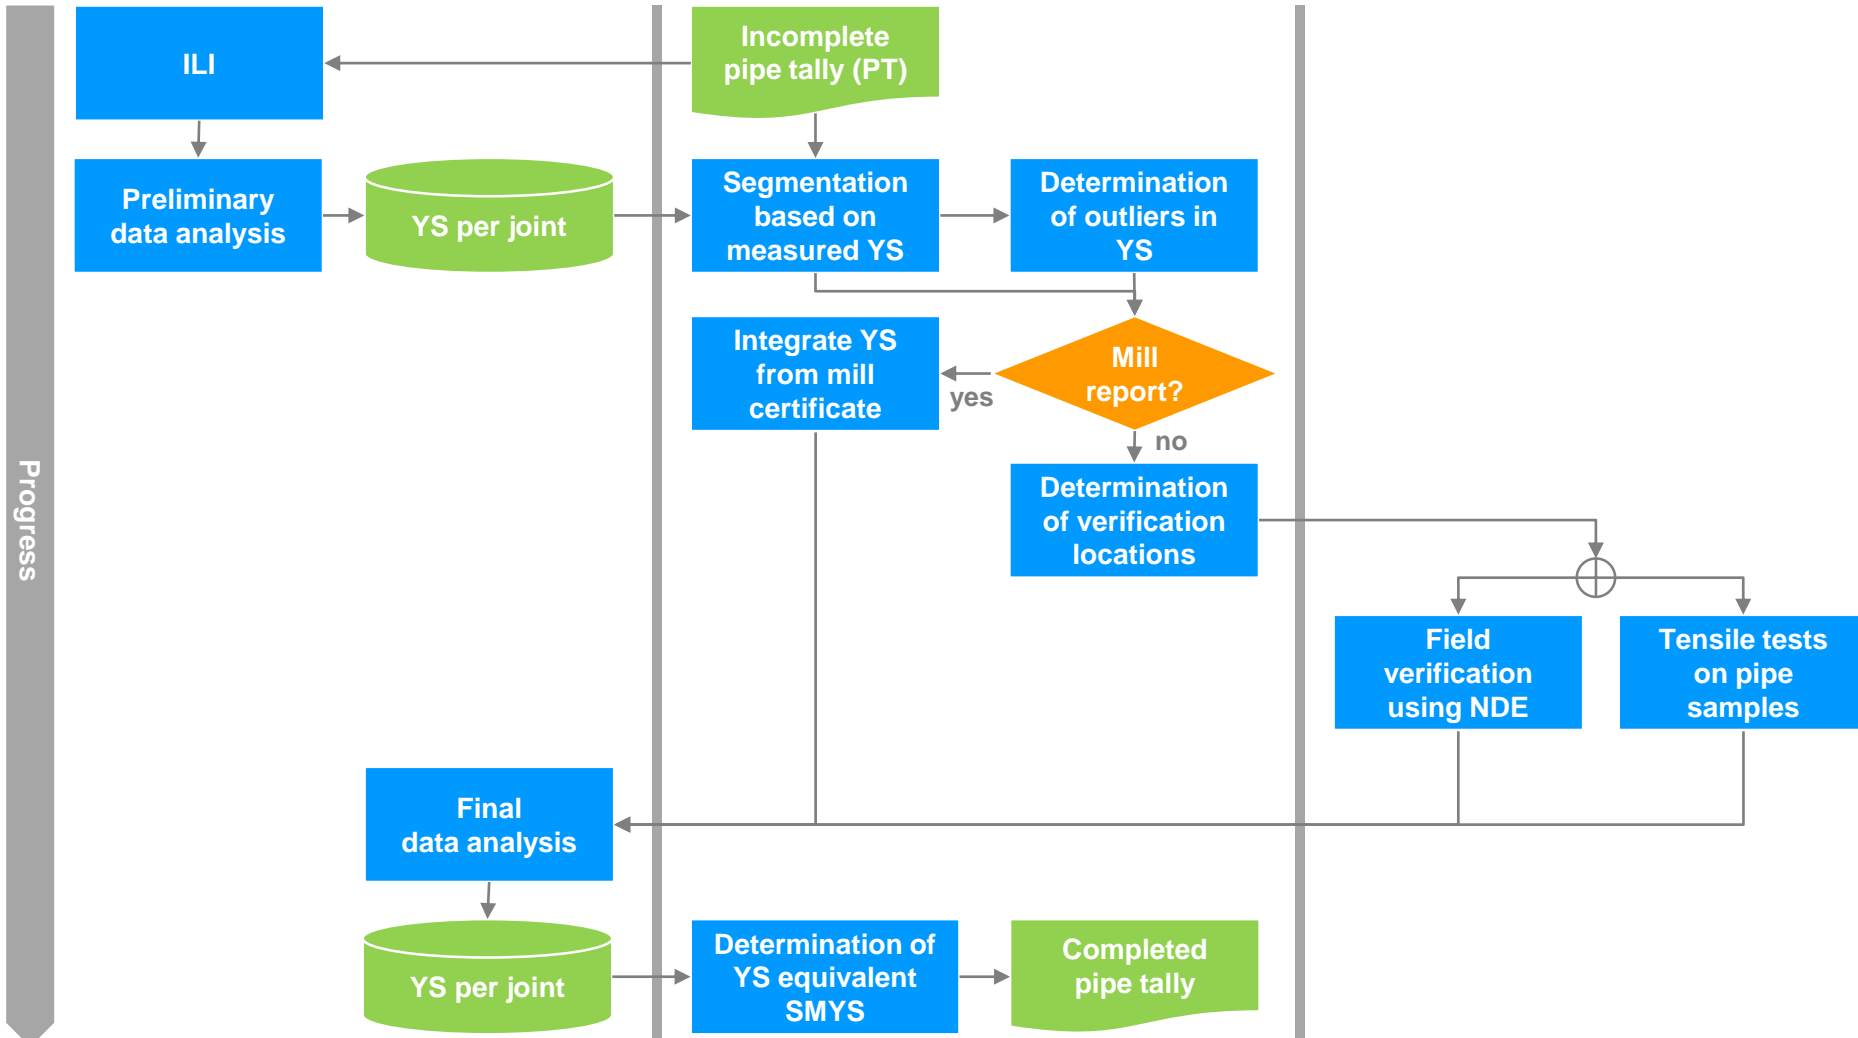
PROCESS OF MAOP RECONFIRMATION COMPLETION OF RECORDS

ILI & Data Analysis

Data Integration

Verification Testing
